Confidential Inspection Report

**Prepared by: Canyon Country Home Inspection, LLC
PO Box 1562
Cottonwood, AZ 86326
928-646-3200 azjones@juno.com**

This home is a two bedroom two bath house it is around 1988 square feet in size and was built in 1981. Most homes have some defects or items that need repair or replacement. This reports intention is to catalog and identify discovered defects for the buyer, it is not intended to pass judgment or reflect

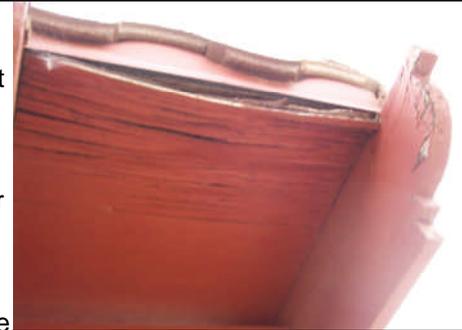
There is some significant moisture damage seen in the plywood soffit under the eave at the northeast corner of the rear deck cover. This indicates a possible roof problem at this location. I recommend a further evaluation by a licensed roofing contractor about this problem and have roof repairs made as needed. I recommend you have a licensed contractor make repairs of this moisture damaged plywood soffit.

Moisture damage at northeast corner

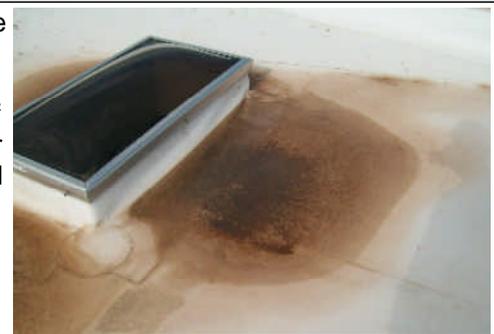
Roof appears to puddle in some locations. There is a significant active roof leak seen around a skylight area at the north end of the home. There is some water damage to the ceiling in the hall area around the return duct for the heating and air conditioning system. The roof appears to puddle in both of these locations. I recommend a further evaluation by a licensed roofing contractor and have roof repairs or replacement done as needed.

Puddle next to this skylight

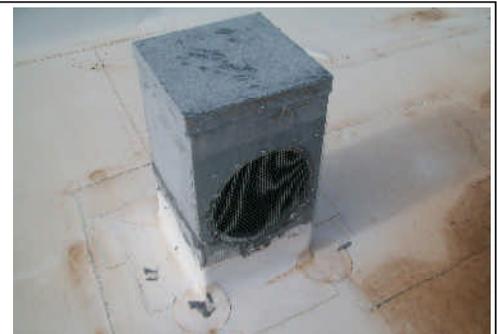
This is open to the interior of the home

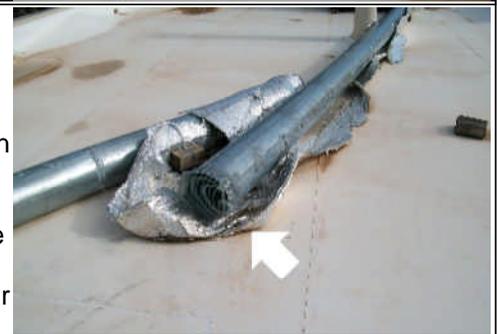
There is a supply duct on the roof that runs from the heating and cooling system over to the north to a duct that leads through the roof into the addition at the north end of the home. This duct is disconnected and a long section of it is laying on the roof. This means that a large amount of supply air from the air conditioner and the furnace just blow out to the outdoors. This creates a great deal of inefficiency due to you are trying to heat and cool the exterior of the home. You also have a wide open duct to the outside

This duct is blowing out to the outside

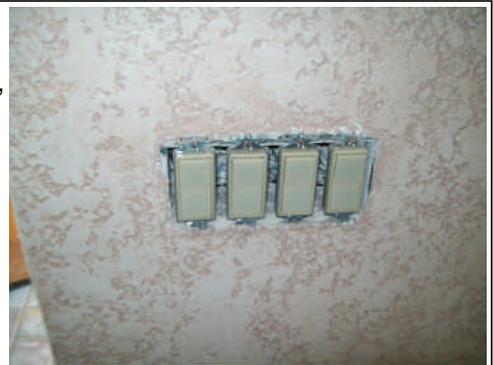
There are missing cover plates seen on outlets in the garage, guest bedroom, and living room, there is a broken outlet in the guest bedroom. I recommend replacement of all cover plates on outlets and switches. I recommend replacement of the damaged outlet by a licensed electrician.

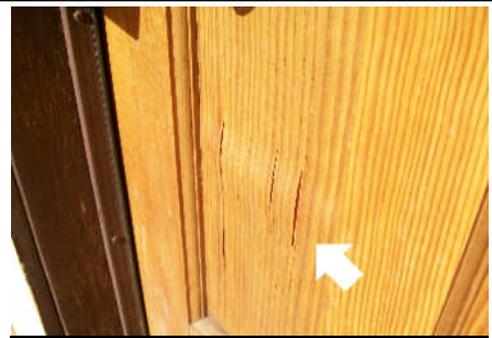
Main entry door appears operational. Dead bolt lock appears operational. Weather strip appears serviceable. Doorbell functions properly. The main entry door appears to have some weather damage seen on the exterior surface. It does not change the operation of the door but is more of a cosmetic problem.

Surface damage to front door

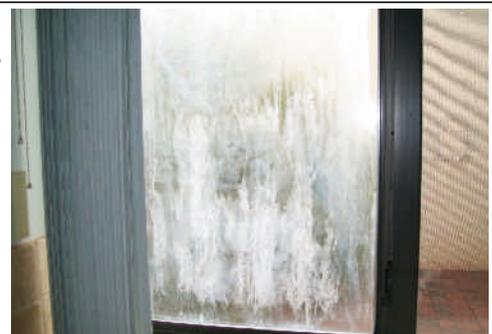
There is a fogged kitchen window at the kitchen sink area. There is another fogged windows seen at the rear master bathroom window. Fogged windows are and indication of a seal leak in an insulated glass window. I recommend replacement of all fogged windows.

Fogged window at kitchen area

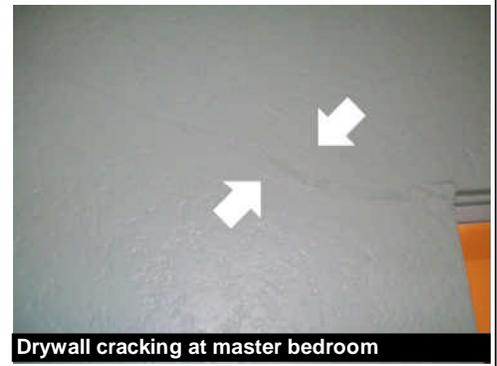
Drywall interior walls. In most cases for the drywall interior walls the general condition appears serviceable. There is some minor drywall cracking seen in some locations. This appears to be expansion and contraction cracking. The most notable is seen in master bedroom above the closet.

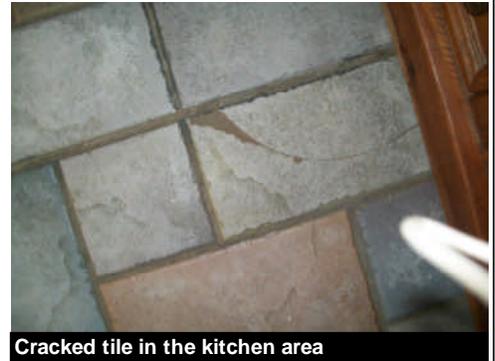
Tile is used in all locations of this home. There is grout cracking and some hairline tile cracking seen in several locations of this home. This is seen in the kitchen running north into the room that is north of the kitchen. It is also seen at the entry area, and in the hall area near the door to the garage. There is also some hairline tile cracking seen on

Cracked tile in the kitchen area

both sides of the toilet in the master bathroom. There is also some significant grout cracking and some missing grout seen at the north side of the living room where it appears a patio area may have been made into an additional living space. In all these locations it appears that this indicates concrete slab cracking. Only the last one has any indication of height difference the rest all appear to be typical expansion type cracking that was tiled over without the proper technique (tile installer error) as seen where there is a loose tile and I could not see any anti fracture membrane in use.

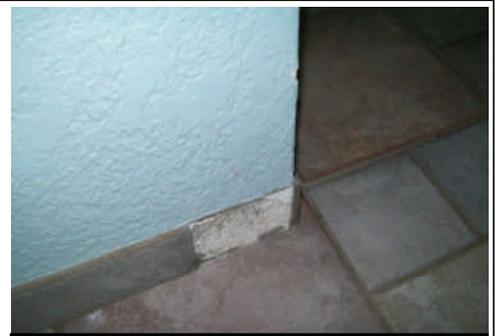
There is tile installed as baseboard in many locations. There are two pieces of tile baseboard missing. I recommend replacement of the missing tile baseboard by a licensed tile contractor.

Missing baseboard tile

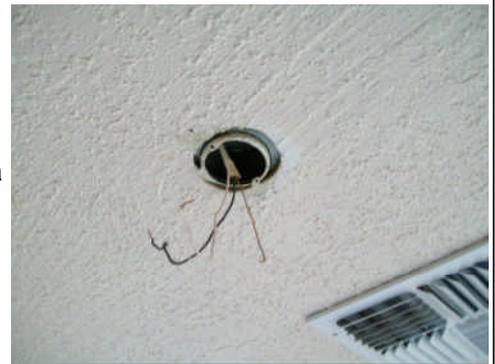
Most lights and light fixtures appear to be in good condition. There is a missing ceiling light fixture in the master bedroom and the north end of the living room. I recommend you have a licensed electrician replace these missing light fixtures so there are no uncontained exposed wires that pose a hazard.

There are also some ceiling light fixtures with missing glass covers. I recommend replacement of missing light fixture covers.

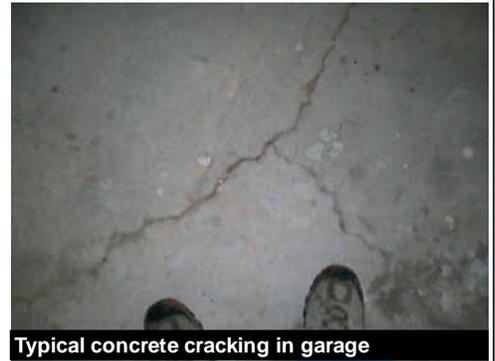
Typical cracks noted. Typical concrete cracking at the garage floor is seen. This appears to be typical expansion and contraction type cracking and does not appear to be a major concern

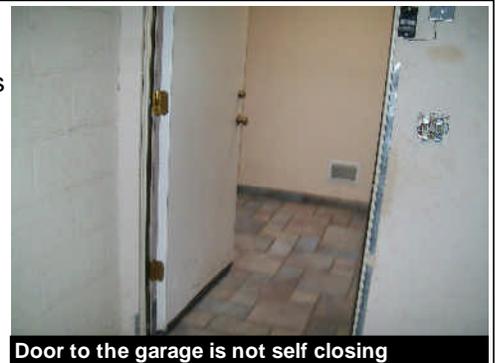
Door to living area from garage is not self closing as it should be. I recommend you make this door a self closing door for safety reasons.

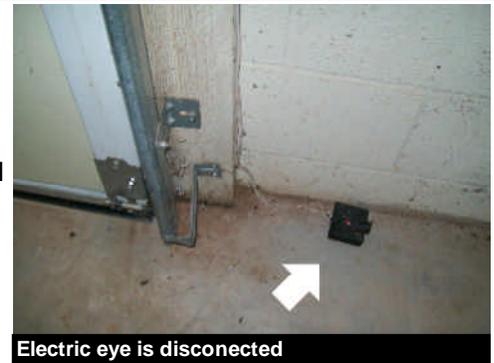
Overhead garage door appears serviceable. Automatic door does not operate as it should. The auto reverse feature is not operational and the electric eye is not installed as it should be. I recommend you have a garage door specialist make a further evaluation and repair as needed. There is a pad lock installed on one of the tracks that could become a problem and get in the way of door operation. I recommend removal of this pad lock.

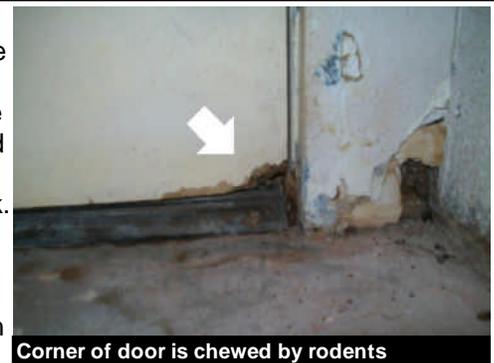
There is evidence that a rodent (pack rat?) has tried to enter the garage. There are chew marks on the door and wall around the side door to the garage. I found more evidence of what appears to be pack rats at the back deck. It appears they are going under the step seen under the sliding glass door at the rear deck. I recommend a further evaluation by a licensed exterminator and have treatment done as needed.

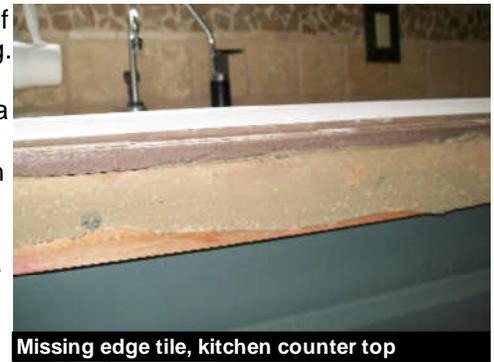
Counters are tile. Edge piece of tile in front of the sink is missing. There is a cracked tile on the counter top to the left of where a refrigerator would go. I recommend a further evaluation by a licensed tile contractor to make repairs, if possible. Cabinets appear serviceable.

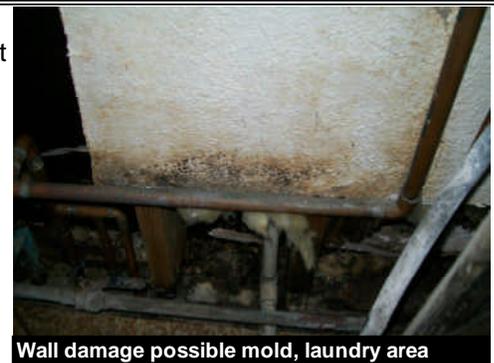
There is some drywall missing in the laundry area. There is some evidence of a past water problem that caused drywall damage in the laundry area. Possible mold is seen. With long term water entry or water leaks there is always the possibility of mold formation. Some types of mold are a significant health risk. Mold identification and testing is beyond the

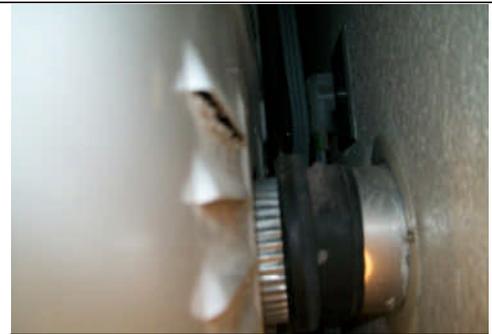
Electric type clothes dryer. Electric type clothes dryer is operational. The dryer vent does not appear to be attached as it should be. I recommend attaching the dryer vent

Dryer vent not attached well

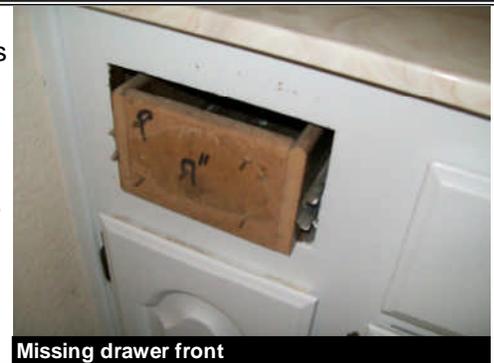
Sink and sink fixtures appear serviceable. Sink drain appears serviceable. Counters appear serviceable. There is a missing drawer front on the vanity cabinet in the hall bathroom. I recommend replacement of this missing drawer front.

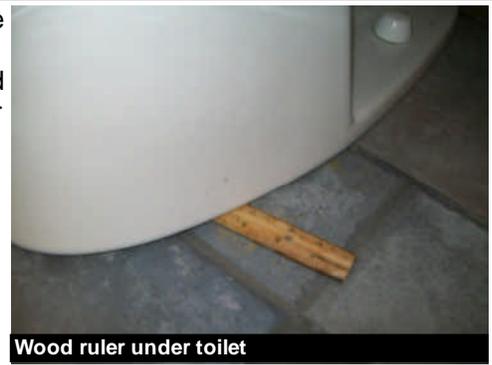
Toilet appears serviceable. The toilet has a wood ruler under it to keep it from rocking back and forth. It may mean that the floor is not flat in this location. If the toilet rocks back and forth it can cause the seal at the trap to leak. You may want to find another solution to the problem besides the wood ruler that is now in use.

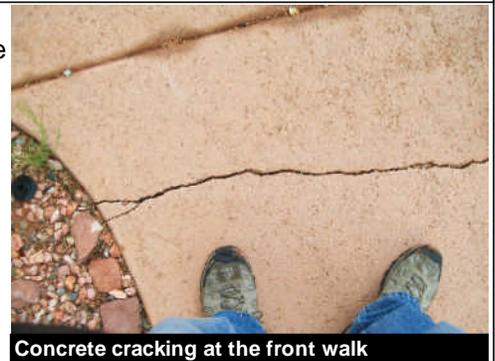
Concrete cracking at front walk noted are typical expansion type cracking. This does not appear to be a major concern.

Concrete cracking at the front walk

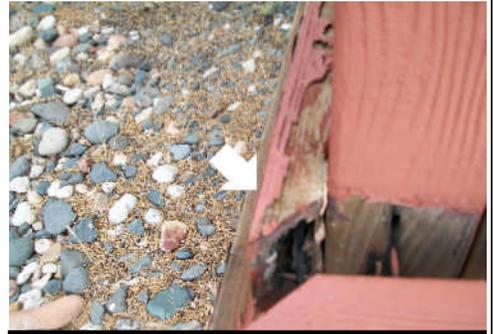
Wood rot damage on railing seen

There is some wood rot damage seen on the bottom horizontal member of the railing at the southeast corner of the deck. I recommend replacement of wood rot damaged wood at the rear deck. I notice some termite damage in deck boards at the south east corner of the deck. I recommend a further evaluation by a licensed exterminator, and take action as needed.

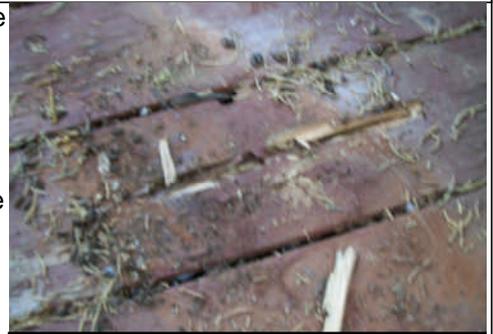
Evidence of termites in deck
